SERVICE BULLETIN No: 105
 REVISION: A, 3 Aug 05. (Prepared 2 Aug 05)
 SUBJECT: Tail Drive System Inspection
 SHIPS AFFECTED: See below
 TIME OF COMPLIANCE: Within the next 10 hours TIS. See below for details.
 FAA APPROVAL: This Service Bulletin is FAA approved.

INSPECTION REPORT FOR SB-105 – PART 2 - Sheet 1/4

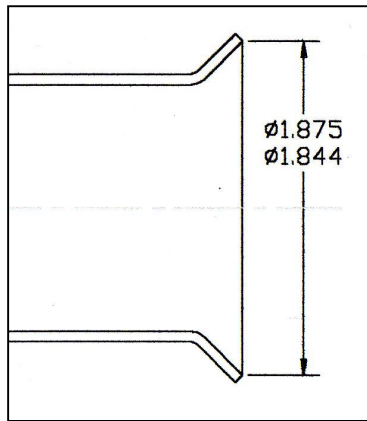
Fig. SB-105-1

2.6 Tail Rotor Gearbox Assembly (p/n 278-200): Assemble the (upper) tail rotor gearbox assembly (p/n 278-200). Add the housing (p/n 249-3). Check the internal alignment of the shaft (p/n 249-10) as follows: Position the assembly such that the shaft is horizontal. The cone end of the male coupling must rest, under its own weight, within .031 inches or below the center of the housing (p/n 249-3) along a vertical line. Repeat the check in at least 4 equally spaced positions when you roll the entire assembly along the shaft axis. The mid-span bearing (p/n 108-64) is part of only some helicopter configurations. If it is part of the ship being inspected then perform the internal alignment check both with and without the bearing installed. If the assembly fails this check then the problem must be found and corrected or the entire assembly must be replaced with an airworthy assembly. Contact the factory if you need assistance. (Ref. SI-10 “Upper Tail Rotor Gearbox Assembly, Installation, Maintenance”)

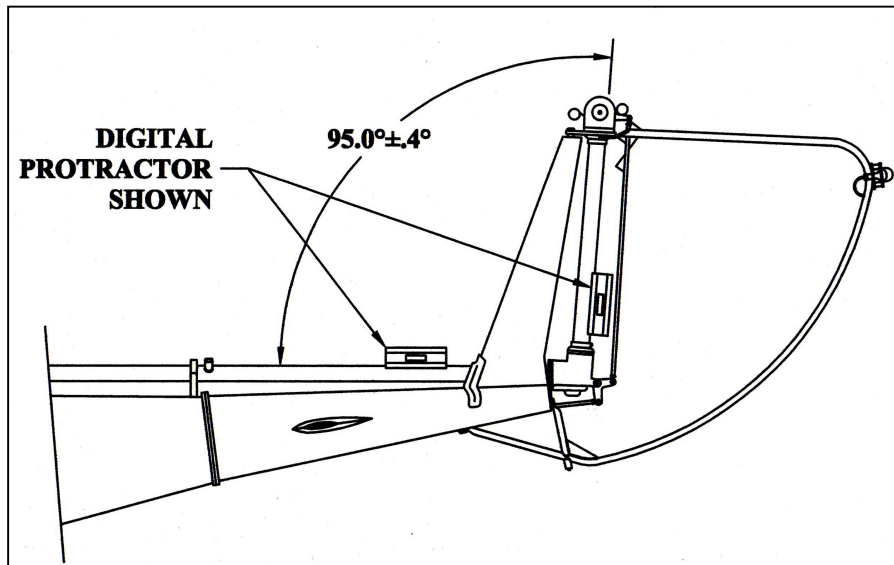
Fig. SB-105-2

- 4) Once the assembly is fully installed and all fasteners are torqued within the required values, measure the angle between the tail rotor shaft housings (p/n 249-3 and p/n 14-13). Angle must be 95.0° ± 0.4°. (See fig SB-105-2)

If the installation fails these checks then the problem must be found and corrected before further flight. Contact the factory if you need assistance. (Ref. SI-10 “Upper Tail Rotor Gearbox Assembly, Installation, Maintenance”)
