SERVICE BULLETIN No: 106
REVISION: ~
SUBJECT: Intermediate Tail Rotor Drive
MODELS AFFECTED: See below.
TIME OF COMPLIANCE: See below.
FAA APPROVAL: FAA Approved 02/15/07.

Introduction

Brantly has had a report of a failure of the horizontal (long) tail rotor drive shaft (p/n 108-31) which is part of the intermediate tail rotor gearbox assembly (p/n 278-100). The purpose of this service bulletin is to inspect the alignment and condition of the shaft and its related components. Alignment and condition is important and must be inspected to ensure safety and part life.

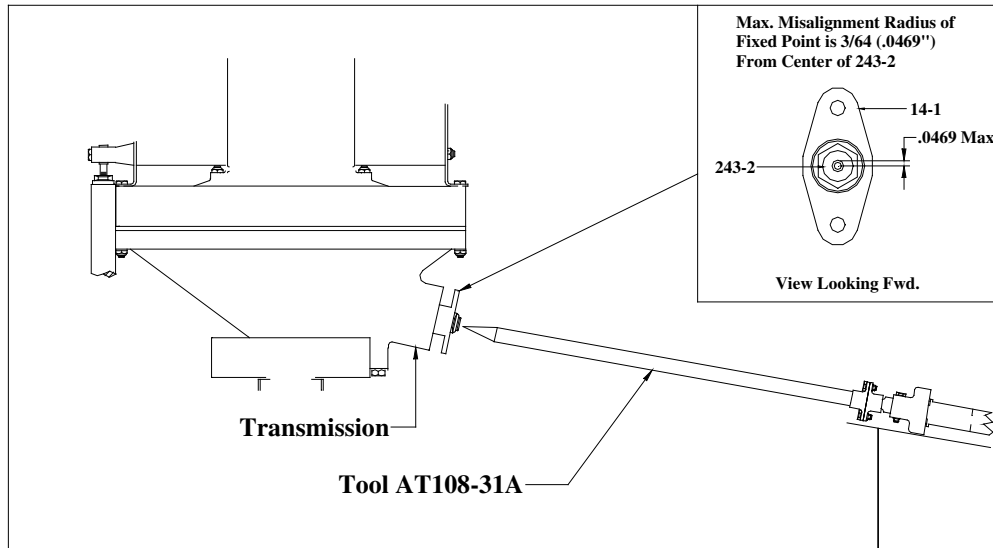
Fig SB-106-2 Forward End Alignment

NOTE	Use calipers with a .001" inch accuracy for this measurement. This dimension should be 3/64 (.0469) inch or less. See fig. SB-106-2.
-------------	--

- 1.5 If the alignment is good, proceed to section 2. If not, place shims under the bearing supports (108-3 & 108-4) to achieve a good alignment. See fig. SB-106-4 for shim dimensions and thickness.
- 1.6 Record the results in part 9 of this service bulletin.

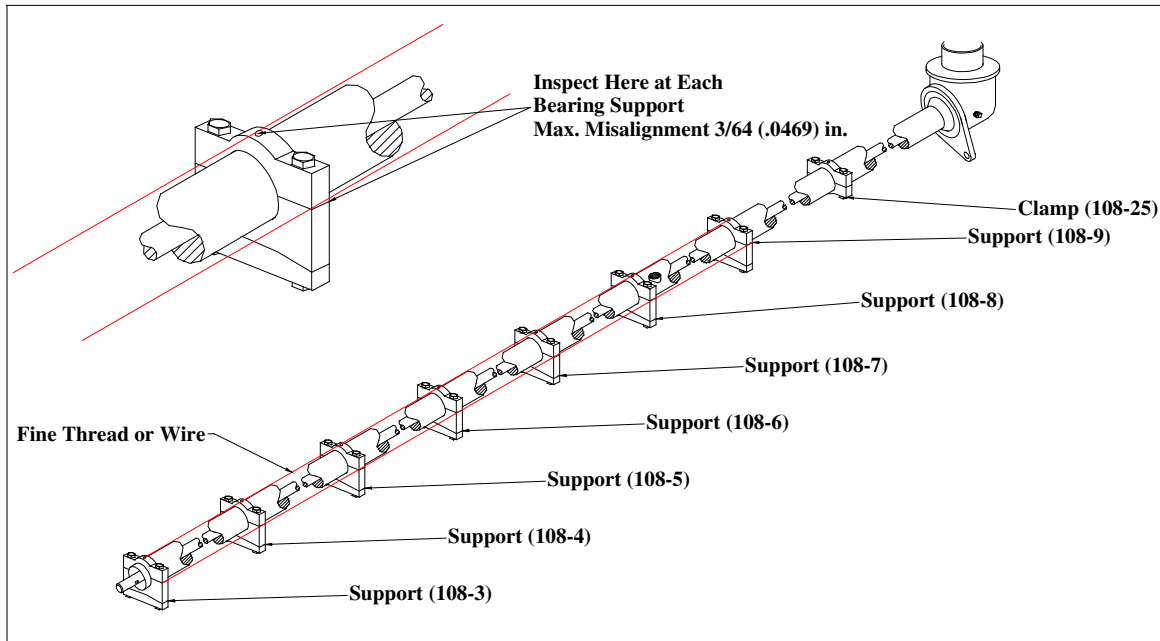
Fig SB-106-3 Bearing Support Alignment

NOTE	Use calipers with a .001" inch accuracy for these measurements. These dimensions should be 3/64 (.0469) inch or less. See fig. SB-106-3.
-------------	--

- 2.5 If the alignment is good, proceed to section 3. If not place shims under the bearing supports (108-4 thru 108-8) to achieve a good alignment. See fig. SB-106-4 for shim dimensions and thickness.

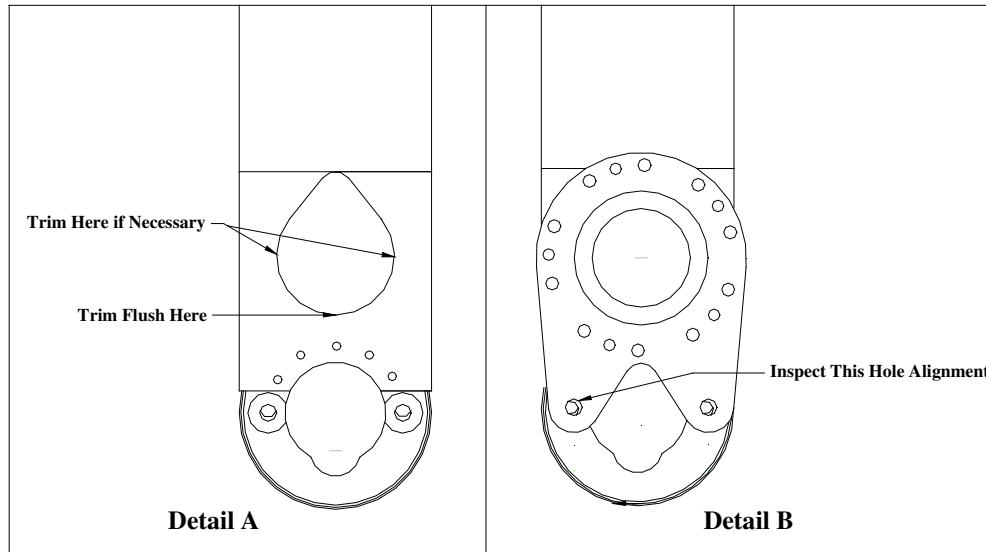
Fig. SB-106-6 Aft End Alignment

- 3.4 Remove the two bolts from the mounting flange of tool AT-278-100 and inspect the alignment of the holes paying particular attention to the left hole.
- 3.5 The holes should not shift more than $\frac{1}{4}$ hole or .0625 inch and tool AT-278-100 should not make contact with the sheet metal hole on the aft side of the tail cone. See fig. SB-106-6 Detail B.

CAUTION	If the misalignment is more than $\frac{3}{32}$ (.0938) inch, replace the shaft (108-31) with a new one.
----------------	--

- 3.6 Use light hand pressure to move tool AT-278-100 in all directions. It should spring back to a position that does not make contact with the sheet metal.
- 3.7 If the hole in the back of the tail cone interferes with this inspection, profile the hole to provide some clearance.

CAUTION	Do not remove more than .062 inch on any side. The bottom should be flush with the top of the bulkhead. Do not remove any material from the bulkhead. Be sure the finished hole is a smooth contour and is de-burred properly. See fig. SB-106-6 Detail A.
----------------	--
