SERVICE BULLETIN No: 106
REVISION: ~
SUBJECT: Intermediate Tail Rotor Drive
MODELS AFFECTED: See below.
TIME OF COMPLIANCE: See below.
FAA APPROVAL: FAA Approved 02/15/07.

Introduction

Brantly has had a report of a failure of the horizontal (long) tail rotor drive shaft (p/n 108-31) which is part of the intermediate tail rotor gearbox assembly (p/n 278-100). The purpose of this service bulletin is to inspect the alignment and condition of the shaft and its related components. Alignment and condition is important and must be inspected to ensure safety and part life.

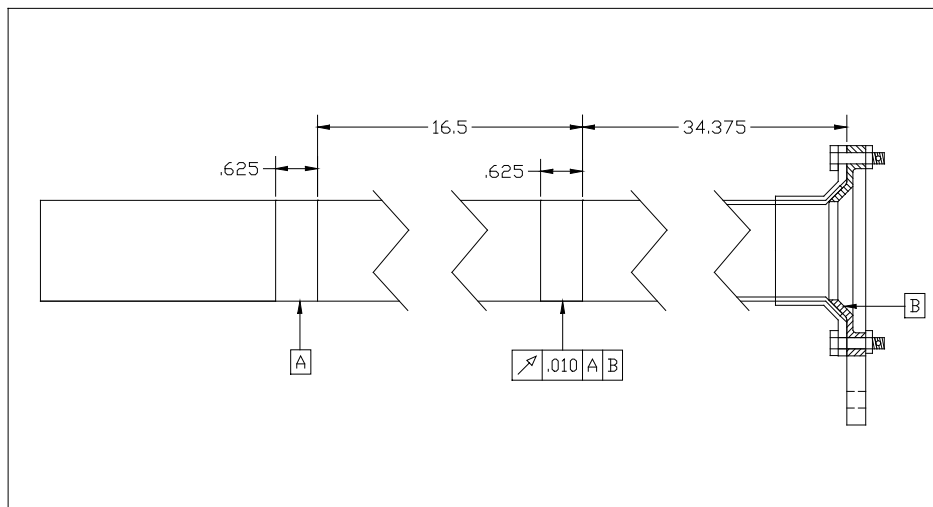
Fig. SB-106-1 AT-278-100 Run-out Inspection

NOTE	Inspect tool AT-278-100 after shipping for damage or bending. If a damaged or bent tool is suspected, return the tool to Brantly for inspection or inspect the tool for run-out per fig SB-106-1.
-------------	---

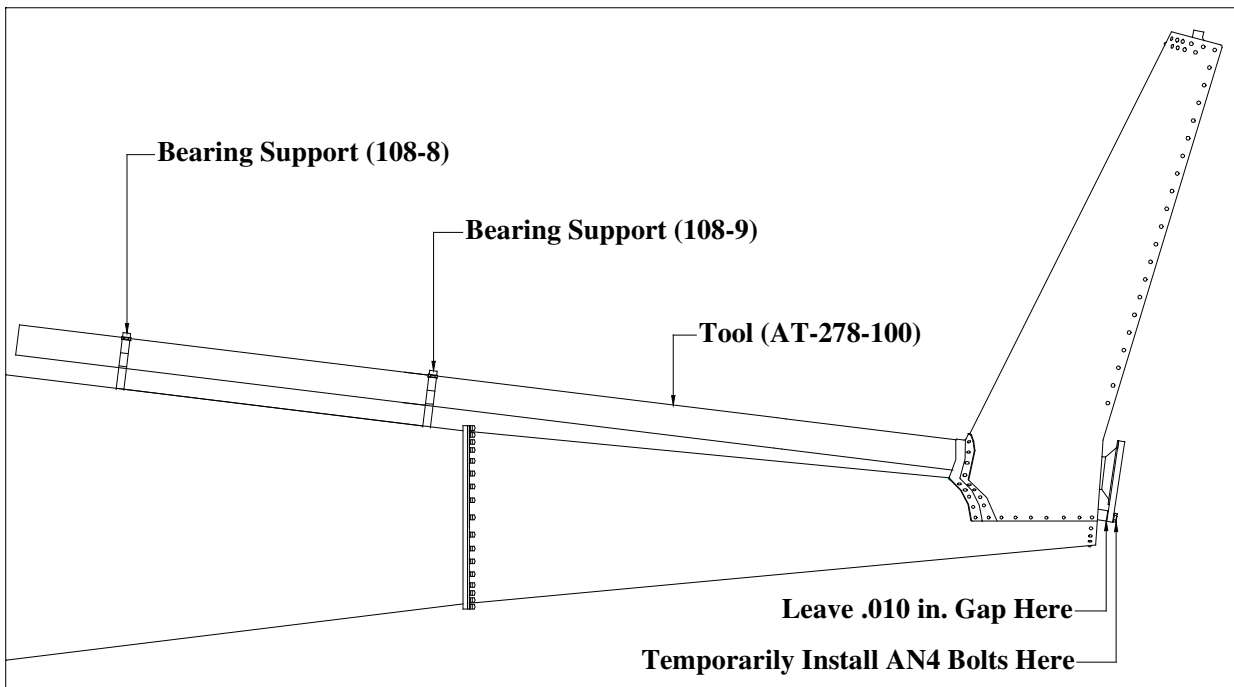
Fig. SB-106-5 Aft End Alignment Tool (AT-278-100) Installation

- 3.1 Remove the tail rotor guard, upper tail rotor gearbox, and intermediate tail rotor gearbox per Brantly maintenance instructions.
- 3.2 Install tool AT-278-100 through the aft end of the tail cone. Install two AN4 bolts through the mounting flange holes of tool AT-278-100 into the bulkhead mounting holes on the aft side of the tail cone.
- 3.3 Leave at least a .010 in. gap between the mounting flange and bulkhead. Install at least the two aft bearing supports (108-8 & 108-9) in place and snug the bolts. See fig. SB-106-5.
